URGENT Field Safety Notice

EPIQ Elite v14.0 Software Issue with C5-1 Transducer

October 2026

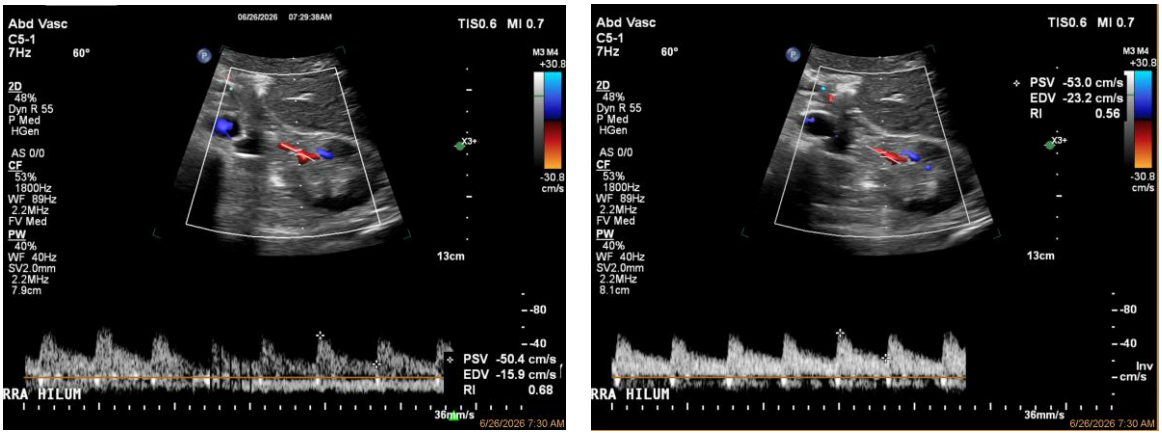
Figure 2. Example with large vessels. (a) Ideal Positioning - SV volume placement in center of lumen. Signal is weak and is not what the user would expect to see given the normal color Doppler signal displayed (Typically gain would be increased by user). (b) Positioning Offset - SV is placed deep to the periphery of the vessel, and a normal PW trace is observed

- Due to possibility of a weak PW Doppler Signal on EPIQ Elite running 14.0 SW, customers are advised not to use C5-1 Abd Vasc Tissue Specific Preset (TSP). Please use a different TSP (e.g., Abd Gen, Abd Renal) within C5-1. Please note that this issue (i.e., Weak PW Doppler signal) is restricted to the Abd Vasc TSP with C5-1 on EPIQ Elite running SW 14.0 only.
- Otherwise, you may continue to use your device in accordance with the IFU.
- Circulate this notice to all users of the device so that they are aware of the product issue and associated hazard / harm.
- Post this notice near the affected unit(s) for ease of reference

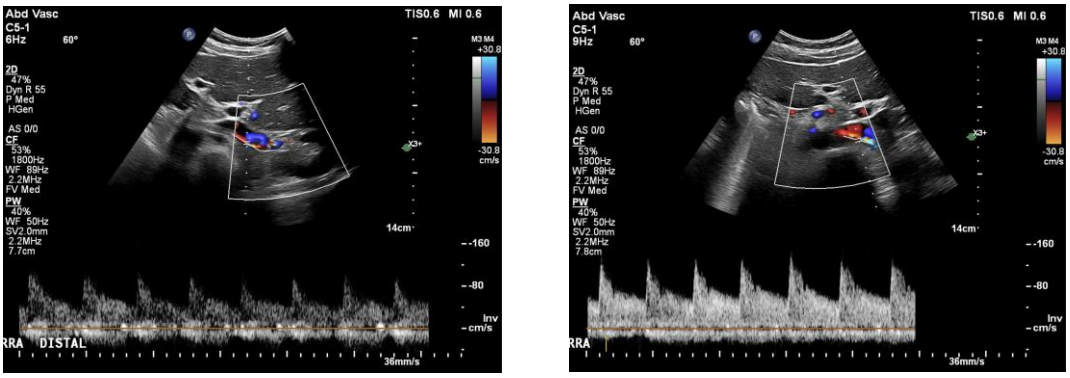
When using a Philips EPIQ Elite system with the C5-1 transducer with the Abd Vasc TSP in Pulsed Wave Doppler mode, the visual representation of the Pulsed Wave sample volume (SV) gate is slightly offset (shallower) to the actual location of the Pulsed Wave measurement. Under default conditions, it will result in an approximate 2mm offset. In larger vessels, the defect may result in reduced signal, which the user may compensate for by increasing PW Gain on the system. In smaller vessels or stenotic flow, the defect may result in underestimation in severity of stenosis. This issue could result in delayed diagnosis or treatment. Inaccurate data may lead to misdiagnosis and incorrect treatment decisions if not identified or corroborated with other diagnostic tools.

Figure 1: Example with small vessels. (a) Ideal Positioning - SV placed near center of vessel lumen. Weaker amplitude signal with PSV of 50.4cm/s. (b) Positioning Offset - SV placed slightly posterior to the vessel resulting in a stronger PW Doppler trace. PSV of 53.0cm/s.

Manufacturer Actions (*SRN: US-MF-000002237)*
Philips will be implementing a software correction free of charge to address the issue.
A Philips representative will contact you to schedule the correction (reference FCO79500580).
